OPERATION BUSTER

PROJECT 9.1 a

F.C.D.A. FAMILY SHELTER EVALUATION

ARCHIE P. FLYNN

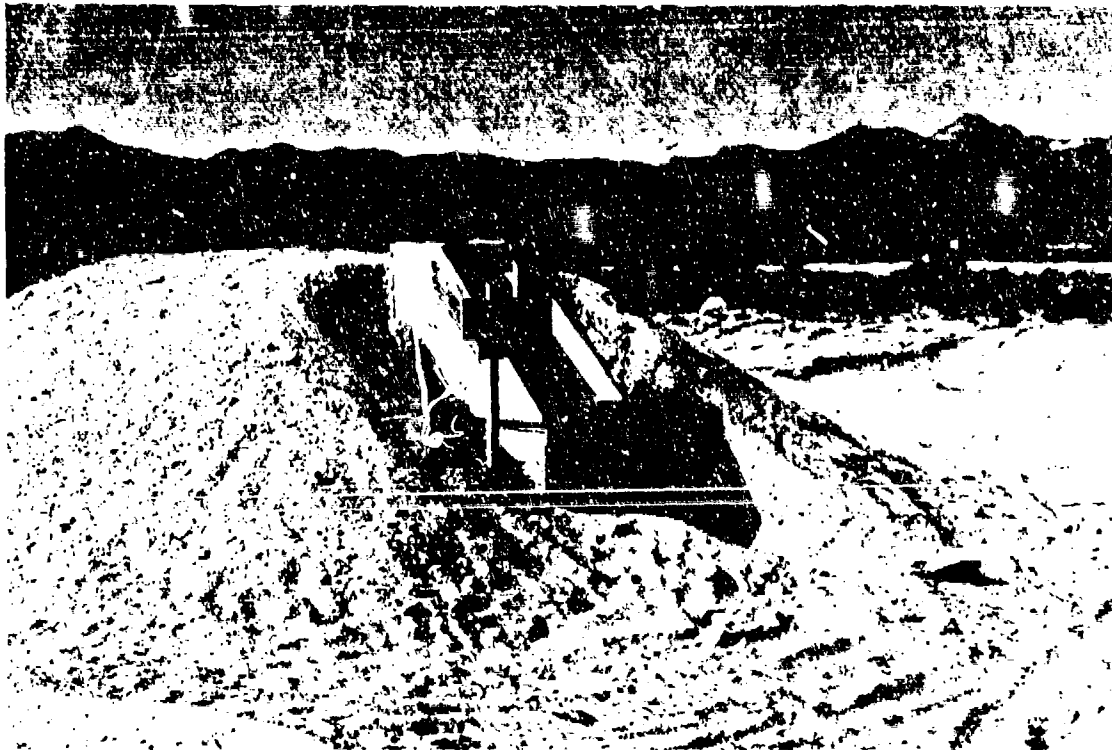
Considerable difficulty was experienced in protecting the entrance construction with earth cover, since the soil lacked cohesive properties after being moved. This was not as serious in below-grade structures as in those built partly-above grade (Figs. 2.6 and 2.7).

Fig. 2.7 Shelter A-17 Completed (partly above grade)
